Phase I Environmental Site Assessment

Commercial Land
5900 Main Street
Rockford, Minnesota

Project B14-02549
May 27, 2014

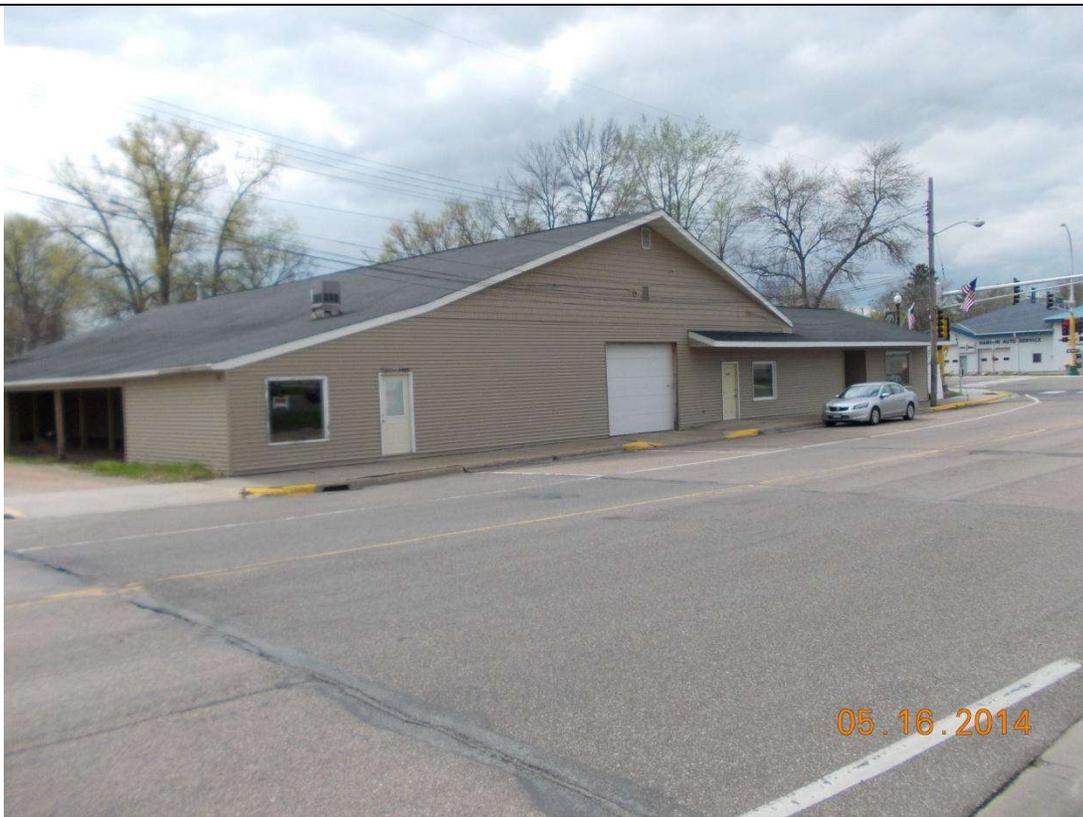
Photograph #1	Commercial Land	B14-02549
Date:	May 16, 2014	
Direction:	Facing southwest from Main Street.	
Subject:	The main Site building.

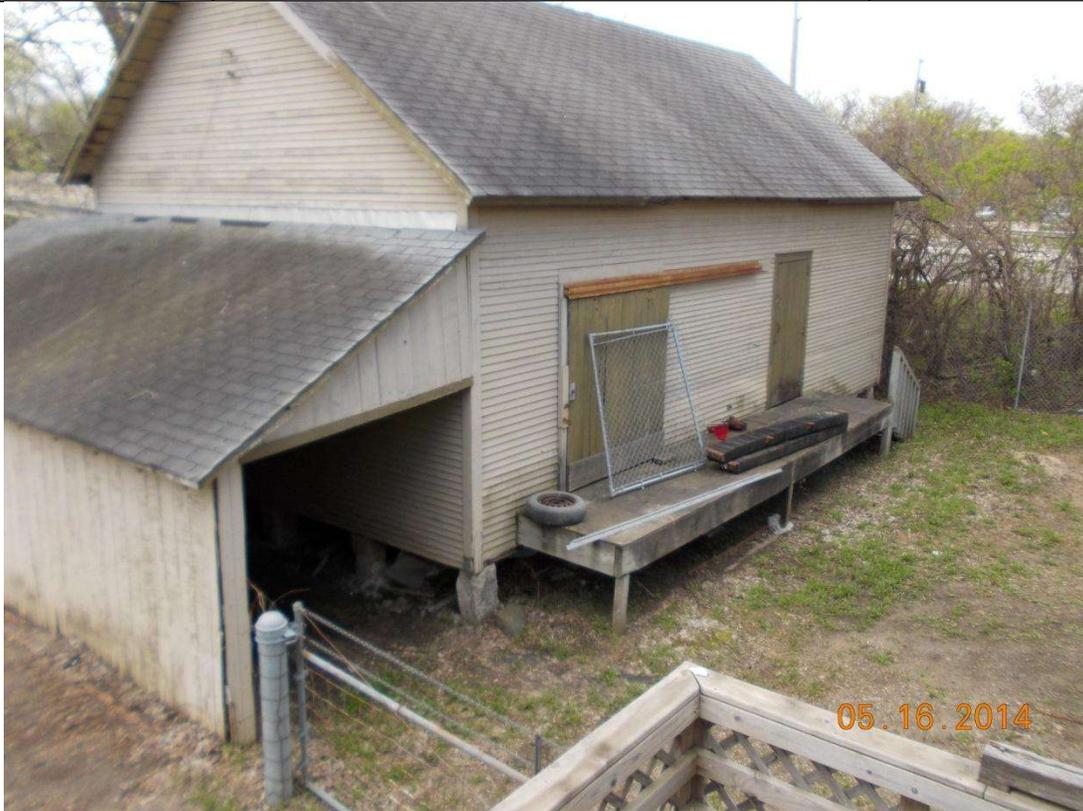
Photograph #2	Commercial Land	B14-02549
Date:	May 16, 2014	
Location:	Facing south from the main Site building.	
Subject:	The smaller Site building.

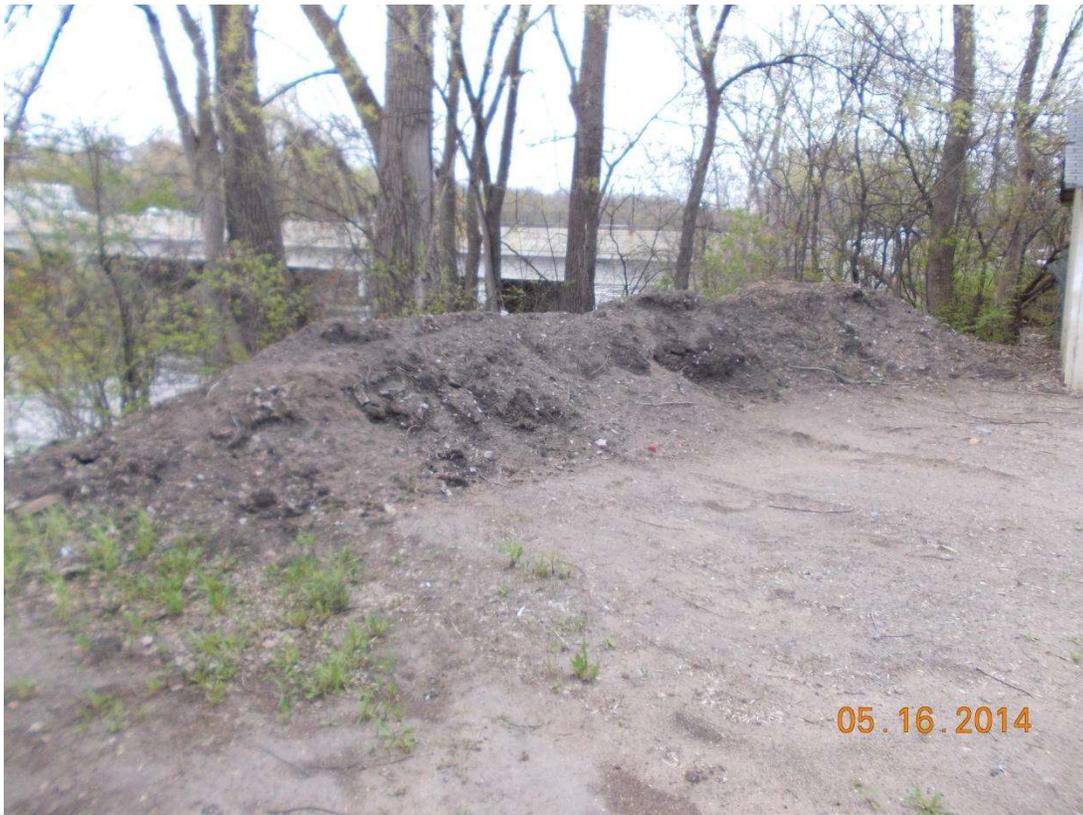
Photograph #3	Commercial Land	B14-02549
Date:	May 16, 2014

No indications of waste disposal areas, observed fill or graded areas by non-natural causes, mounds, depressions, or burn pits were observed at the Site at the time of the reconnaissance, with the exception of a soil mound located near the southern corner of the Site. There were no obvious indications of potentially hazardous materials noted in the soil mound at the time of the Site reconnaissance.

Direction:	Facing south near the southern corner of the Site.	
Subject:	A soil mound.

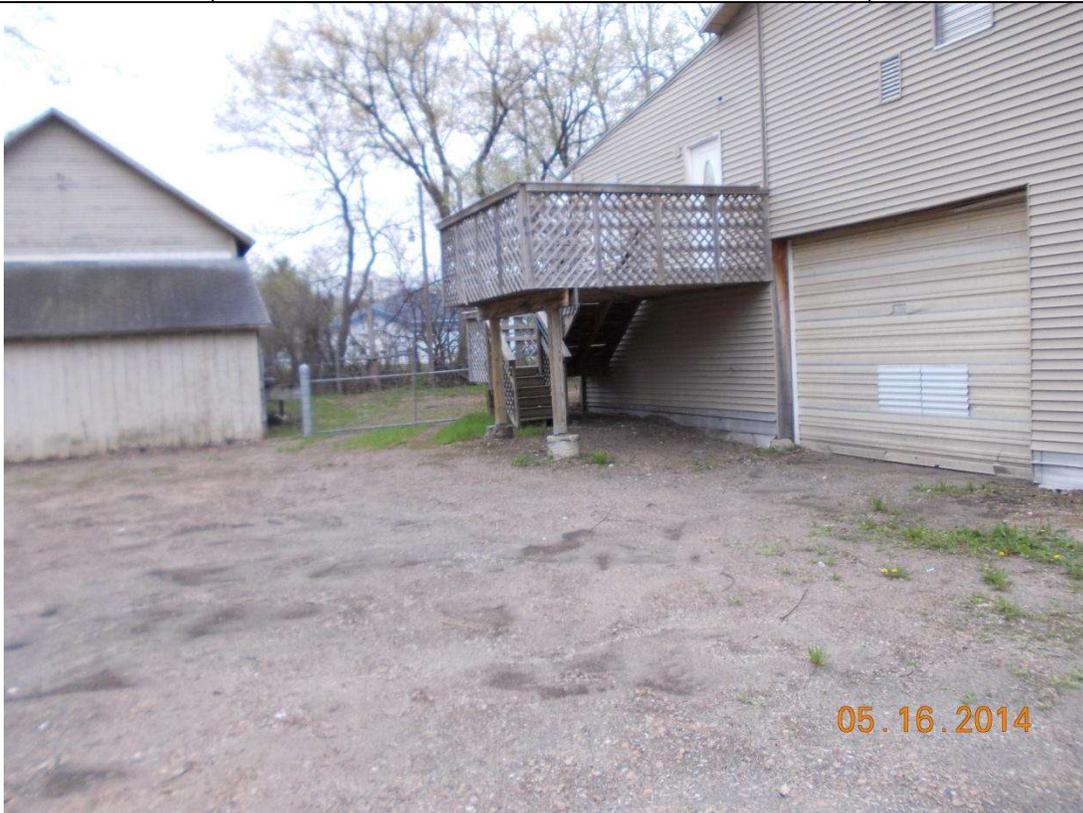
Photograph #4	Commercial Land	B14-02549
Date:	May 16, 2014

Direction:	Facing northwest from the central portion of the Site.	
Subject:	The central portion of the Site.

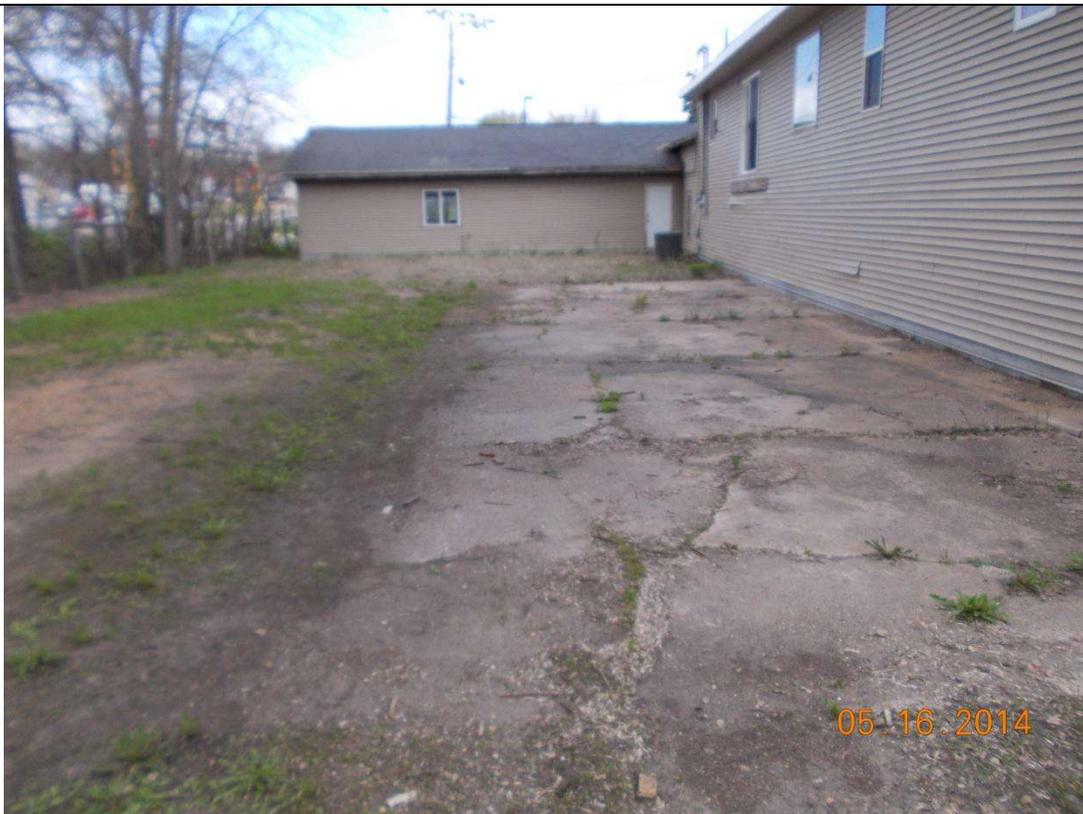
Photograph #5	Commercial Land	B14-02549
Date:	May 16, 2014	
Direction:	Facing northwest from the western portion of the Site.	
Subject:	The western portion of the Site.

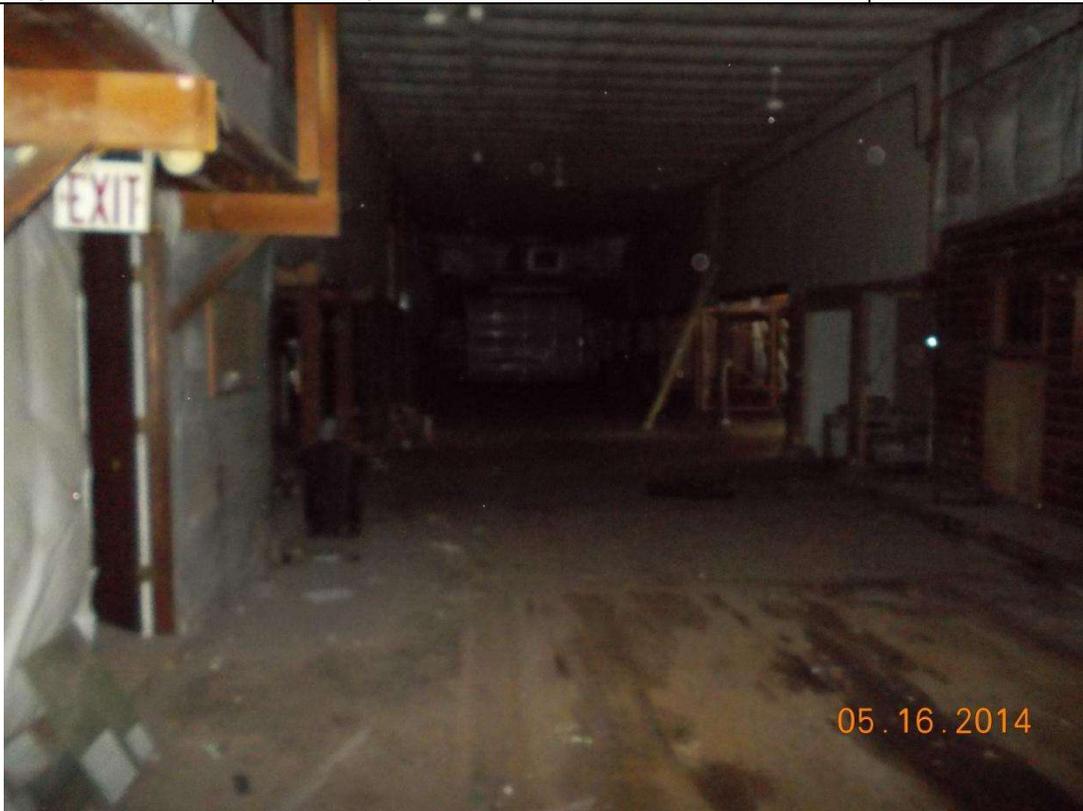
Petroleum stains were noted on the wooden and concrete floor located within the central portion of the Site building. Staining was not noted on the gravel beneath the wooden floor, where easily observed, at the time of the Site reconnaissance.

No indications of current and/or historic use, storage, staining, or spills of petroleum product were observed at the Site at the time of the reconnaissance, with the exception of some staining noted on the concrete and wooden floor of the central portion of the Site building. Observation of the interior of the Site building was limited as the building had no lighting.

Photograph #6	Commercial Land	B14-02549
Date:	May 16, 2014	
Direction:	Facing southeast from the central portion of the main Site building.	
Subject:	Surficial staining noted on the wooded floor of the weigh scale and the interior of the central portion of the main Site building.

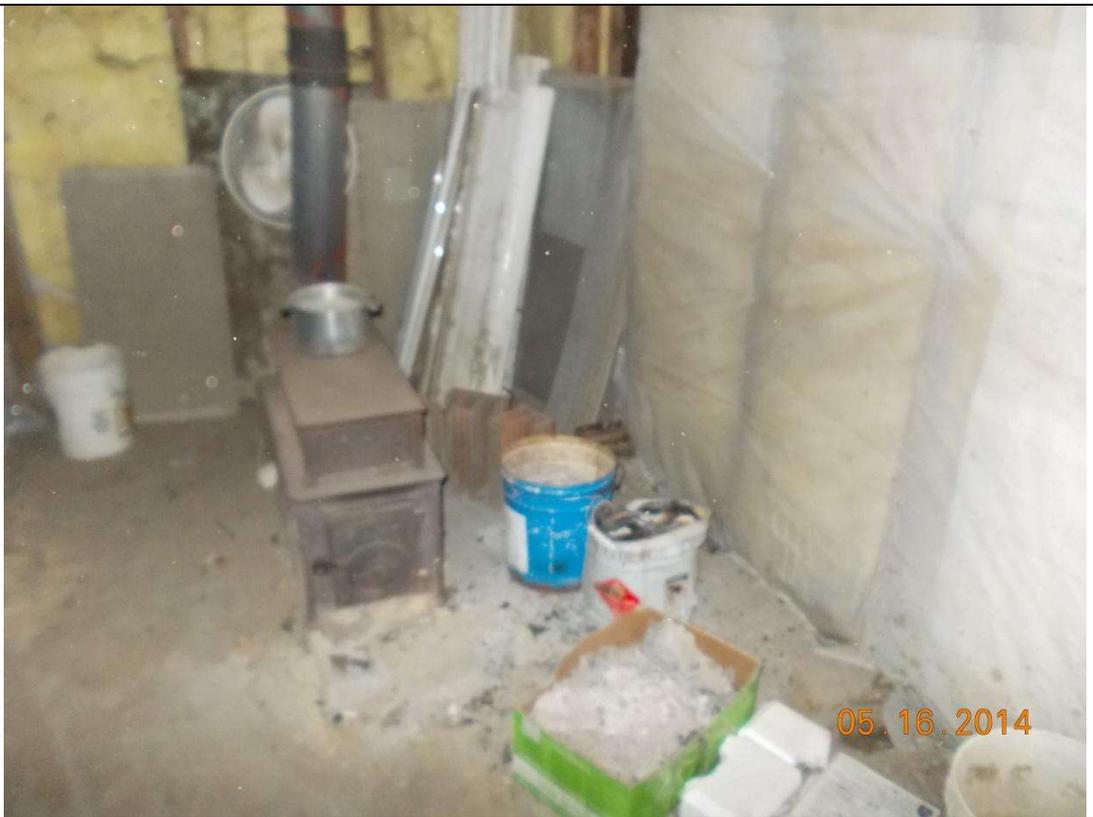
Photograph #7	Commercial Land	B14-02549
Date:	May 16, 2014	
Direction:	Facing north near the eastern corner of the main Site building.	
Subject:	A wood stove and containers of ash.

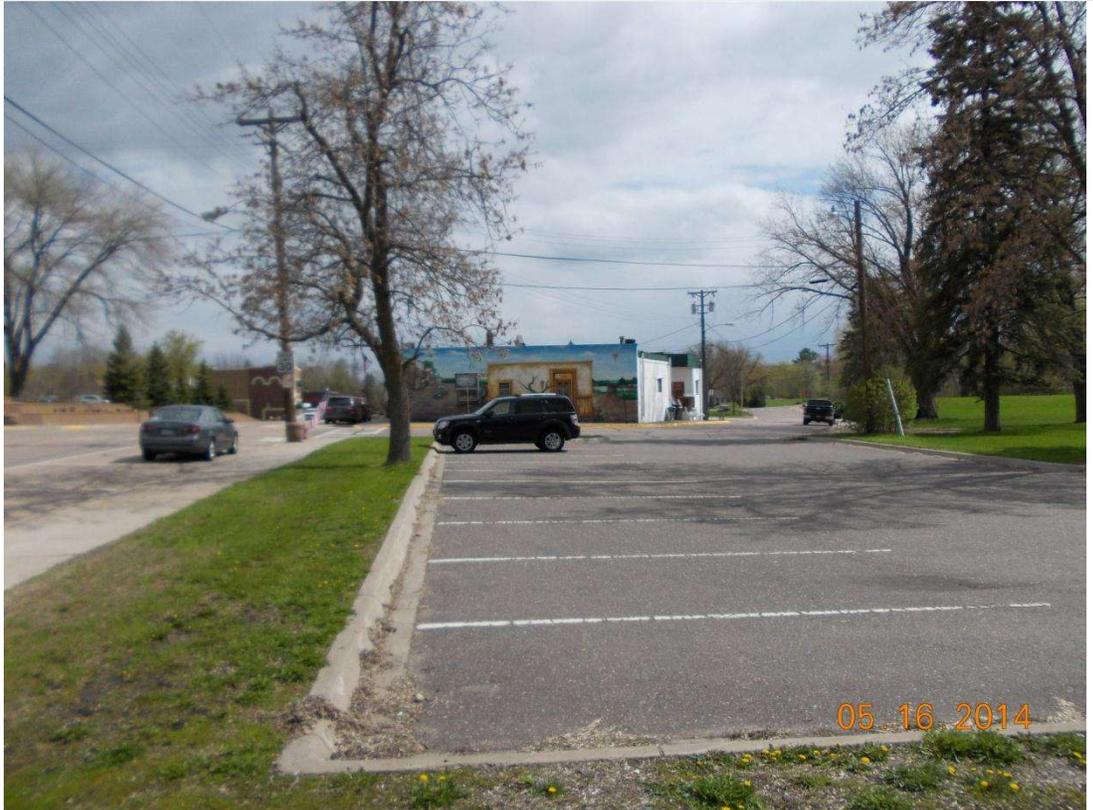
Photograph #8	Commercial Land	B14-02549
Date:	May 16, 2014	
Direction:	Facing northeast near the northern corner of the Site.	
Subject:	The adjoining properties to the northeast and beyond.

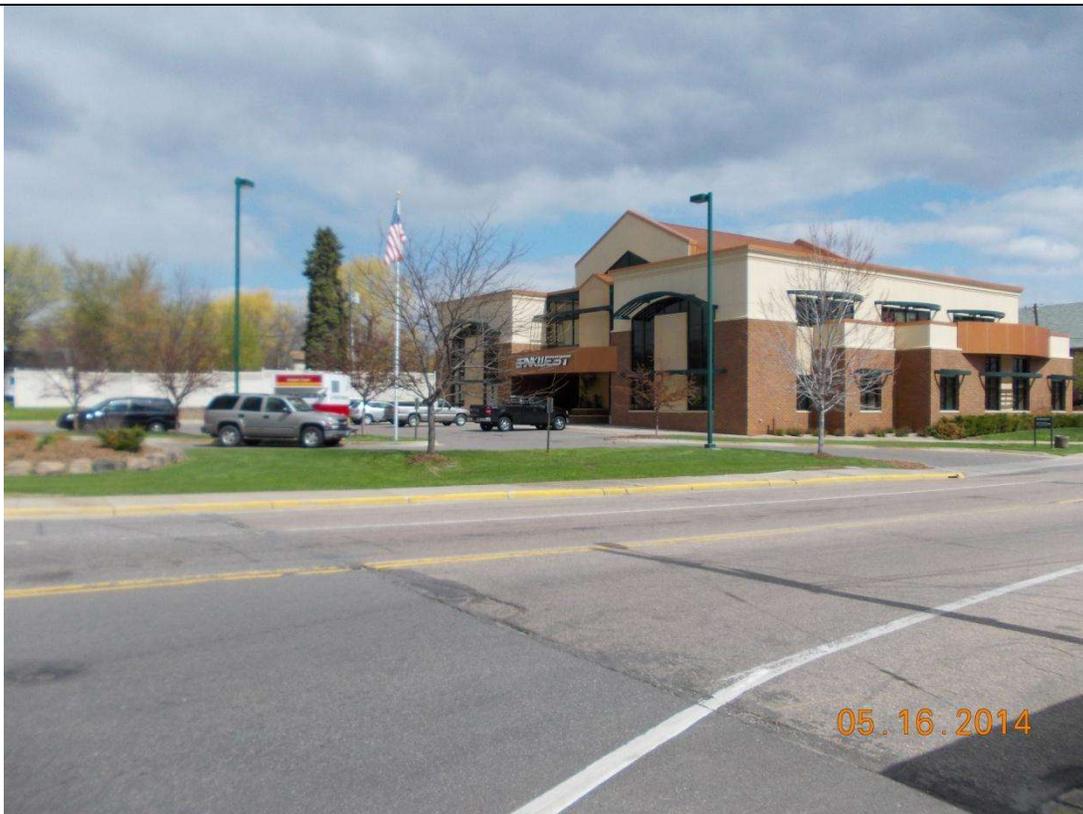
Photograph #9	Commercial Land	B14-02549
Date:	May 16, 2014	BRAUN INTERTEC
Direction:	Facing north from northwest corner of the Site.	
Subject:	The adjoining property to the north.

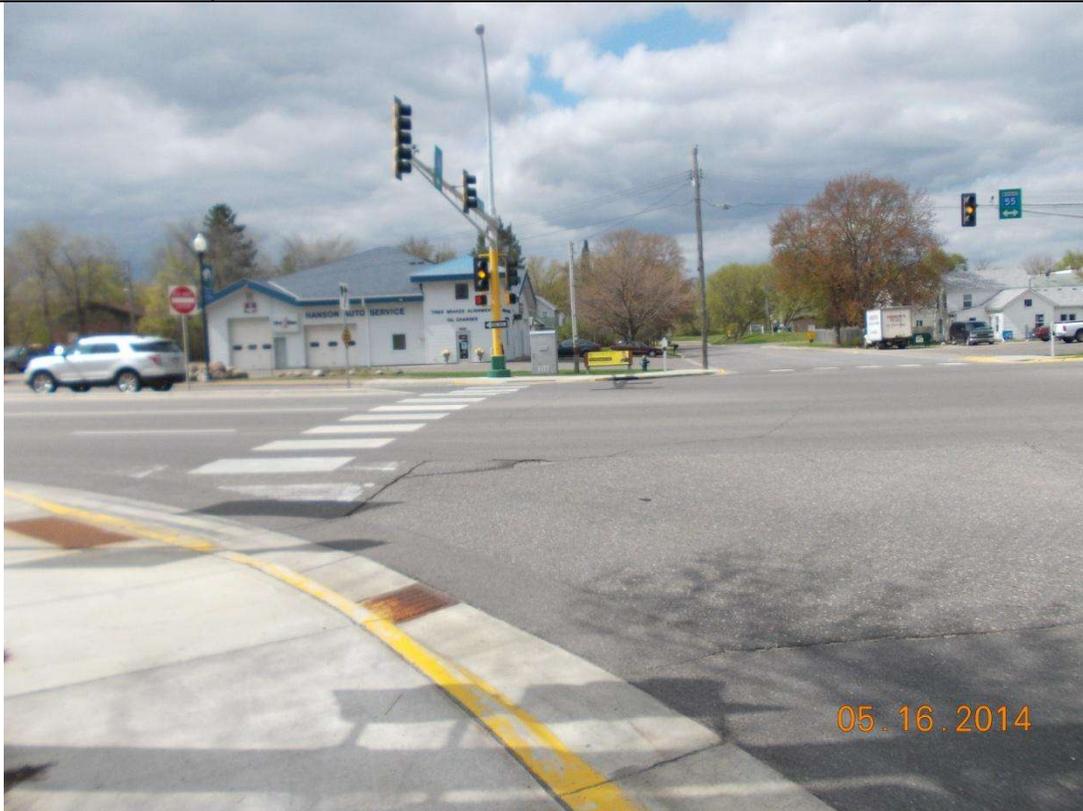
Photograph #10	Commercial Land	B14-02549
Date:	May 16, 2014	BRAUN INTERTEC
Direction:	Facing southwest from the northwest corner of the Site.	
Subject:	The adjoining property to the southwest.
